VESSEL INSPECTION COMMISSIONED BY:

Solar 6

Alex Lloyd

17/03/2022

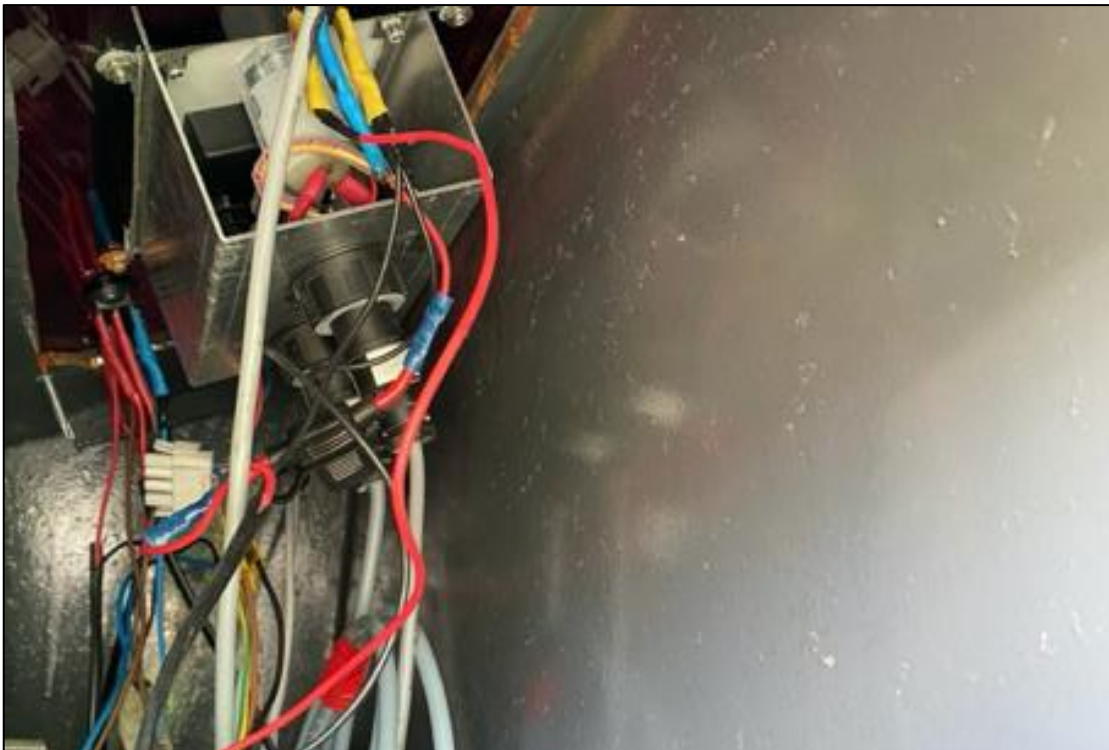
At the time of inspection, much of the cabling was found unprotected and unsecure. Cabling should be clipped and sheathed to protect the cables from chafing overtime. Best practice would have the cabling protected in plastic trunking and secured every 30cms (ISO, 2012. *Small craft — Electrical systems — Extra-low-voltage d.c. installations*. 3rd ed. Geneva, Switzerland: International standard ISO 10133).

Cabling runs to the digital display and speed control binnacle and is routed through metal openings without sheathing.

Photograph 2 – Unsupported and unprotected wiring under dashboard.

Many electrical cables were found running unprotected through steel bulk heads.	Install chaffing/vibration protect to all cables running through steelwork.

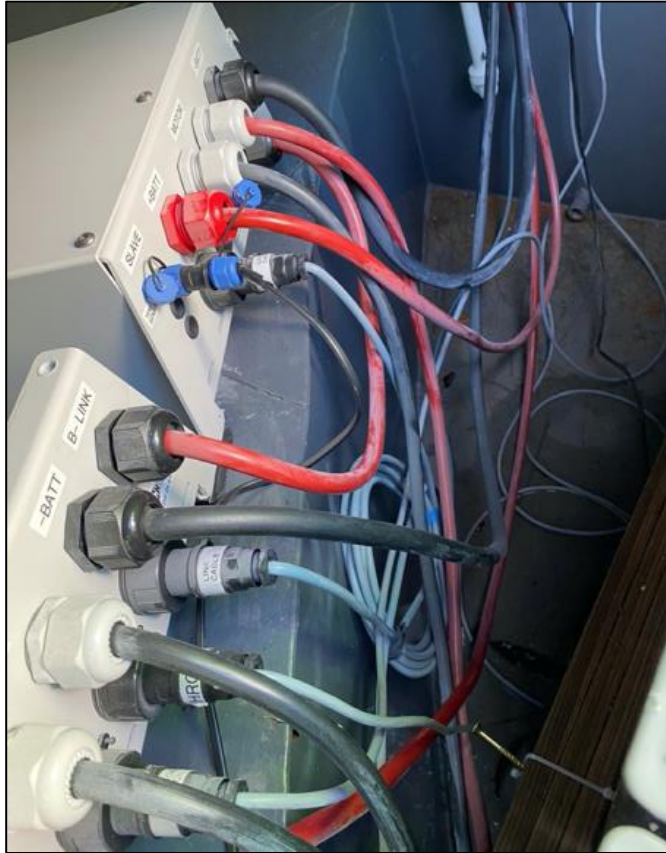
Photograph 3 – Unsupported and unprotected cabling from and to the motor controllers,

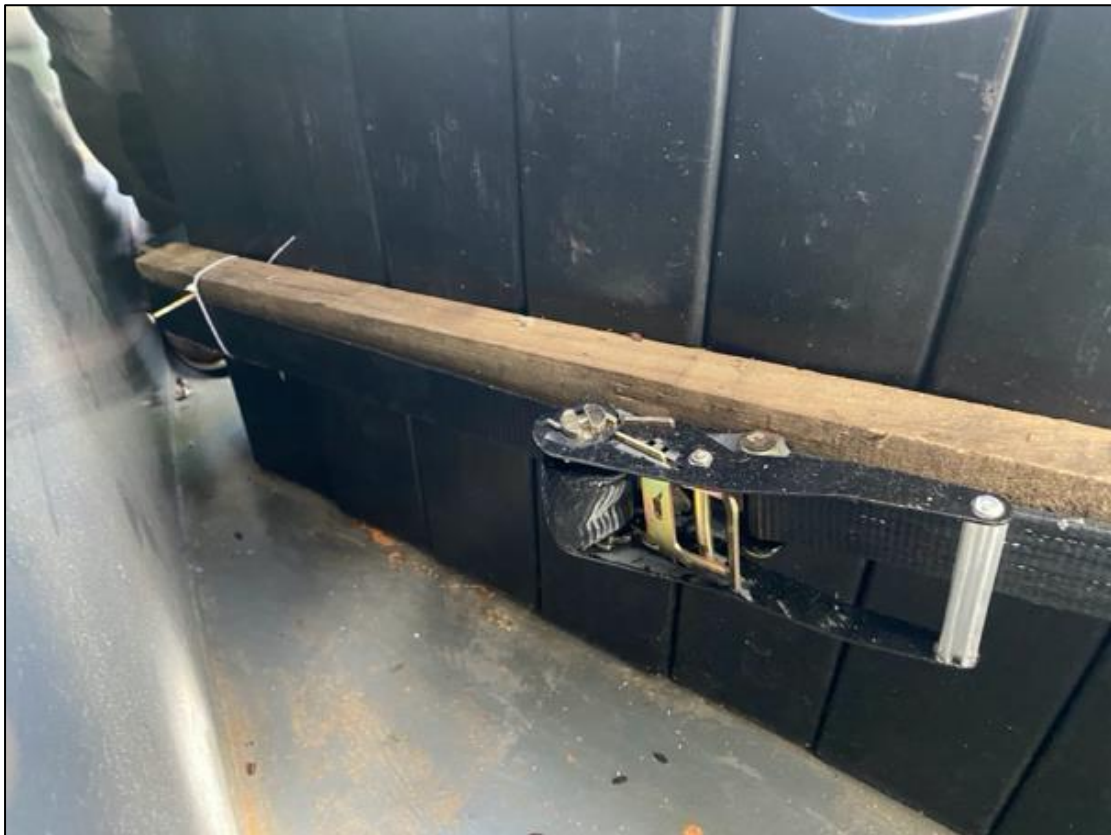
At the time of inspection, twenty-four 2-volt batteries were installed in the engine space of the vessel. Batteries are installed directly onto the metal soul plate and inadequately secured using a single ratchet strap. Load from the ratchet strap was spread using lengths of timber.

The single ratchet strap is considered inadequate. Batteries should be installed in a manner to restrict their movement horizontally and vertically considering the intended use of craft, including trailering, craning and movement by road. A battery as installed shall not move more than 10mm in any direction when exposed to a

force corresponding to twice the battery weight. With light force applied, the individual batteries show signs of movement beyond the 10mm recommendation. Guidance on battery storage and securing arrangements is detailed within the following literature:

Photograph 4 – Current battery securing arrangement. Batteries installed directly on sole plate.

48-volt battery pack is inadequately secured.	Install batteries in appropriately sized timber/fibre glass/plastic battery box with lid.

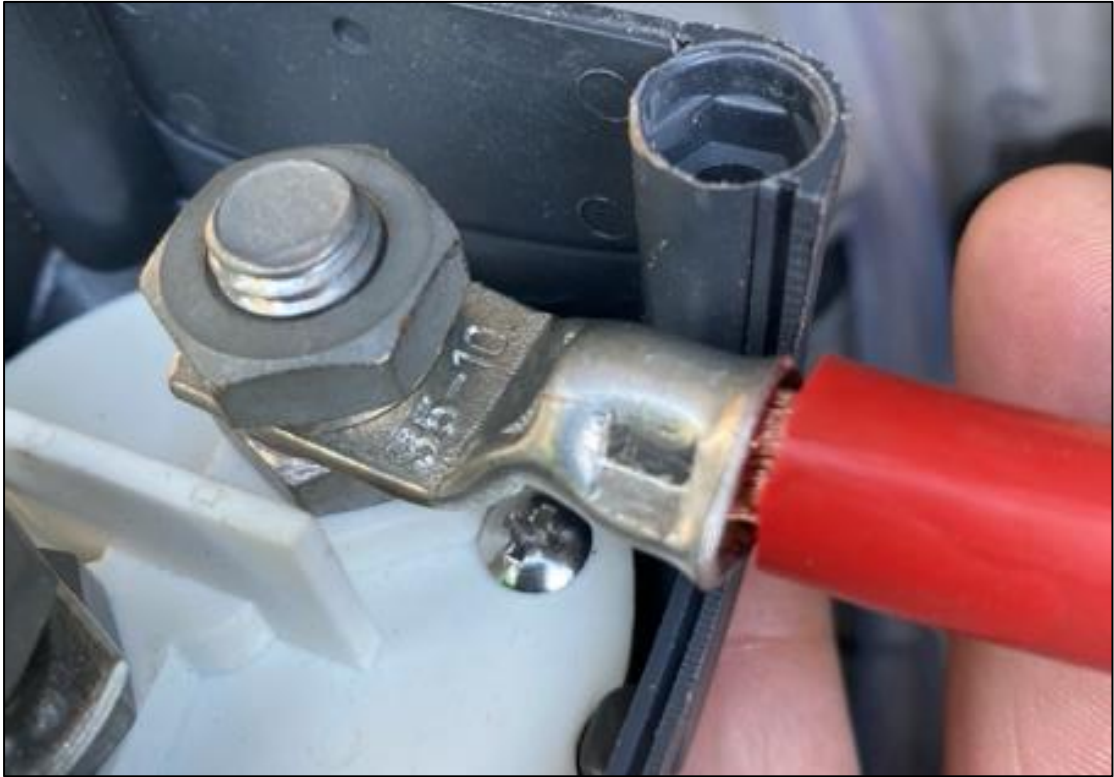
At the time of inspection, many of the connections between the copper tube terminals and cable were found inadequately made. The tooling marks on the crimps show that incorrect tooling had been used. Connections, including the battery cut off switch connection, were found with the incorrectly sized terminals attached to incorrectly sized cable.

Photograph 5 – Cable end crimped using improper tooling.

Cable connections/termination between fuse-holder, battery switch and batteries are inadequately made.	All terminations should be correctly crimped using the correct tools. Copper tube terminals should be covered with heat shrink.

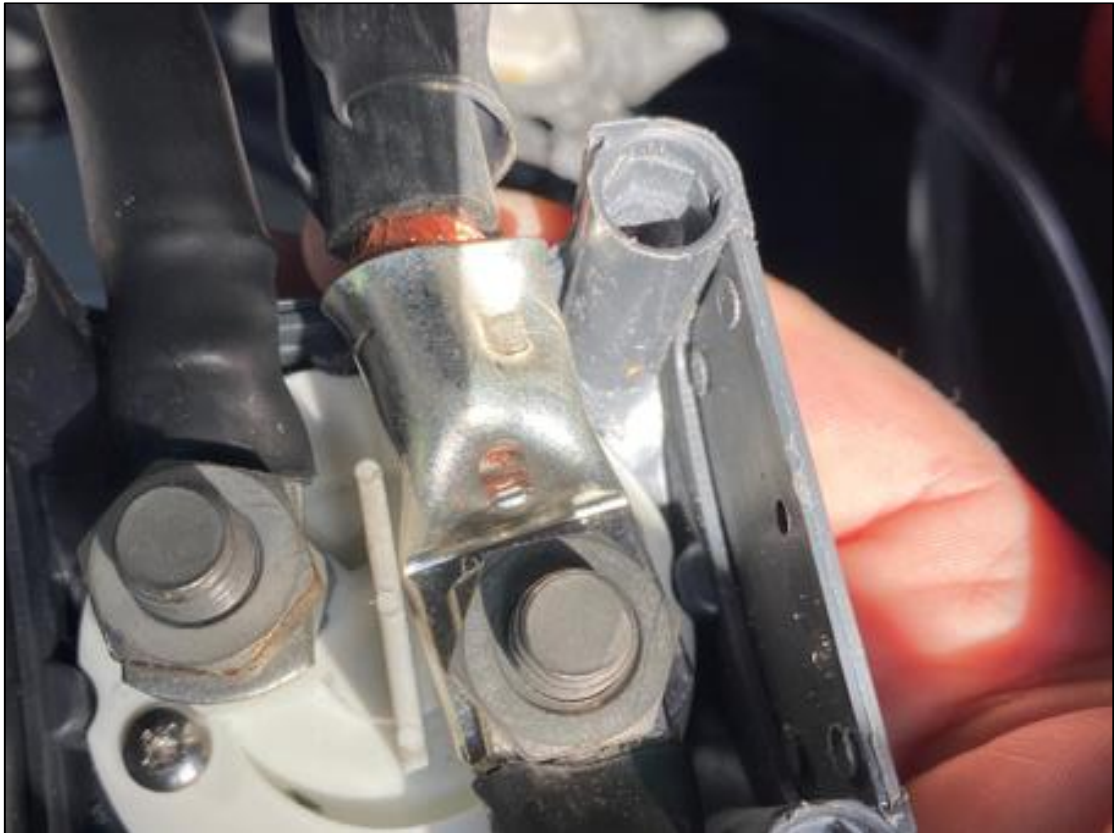
Photograph 6 – Cable end crimped using improper tooling.

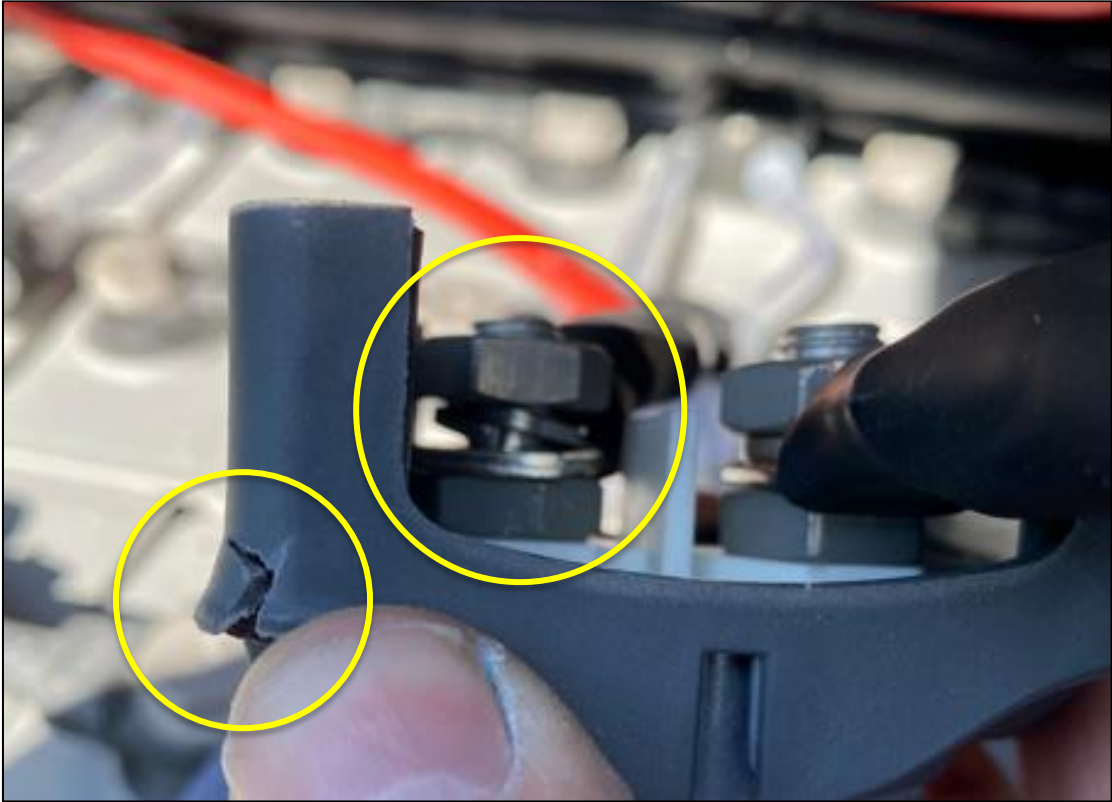
Photograph 7 – Loose termination on battery switch and battery switch housing cracked.

Furthermore, the battery switches are mounted using incorrectly sized self-drilling machine screws. Only two of the four mounting points have been used. The outer casing of the battery switches has been damaged due to the oversized machine screw heads.

Loose terminal connection to battery switch.	Tighten to manufactures torque specification.

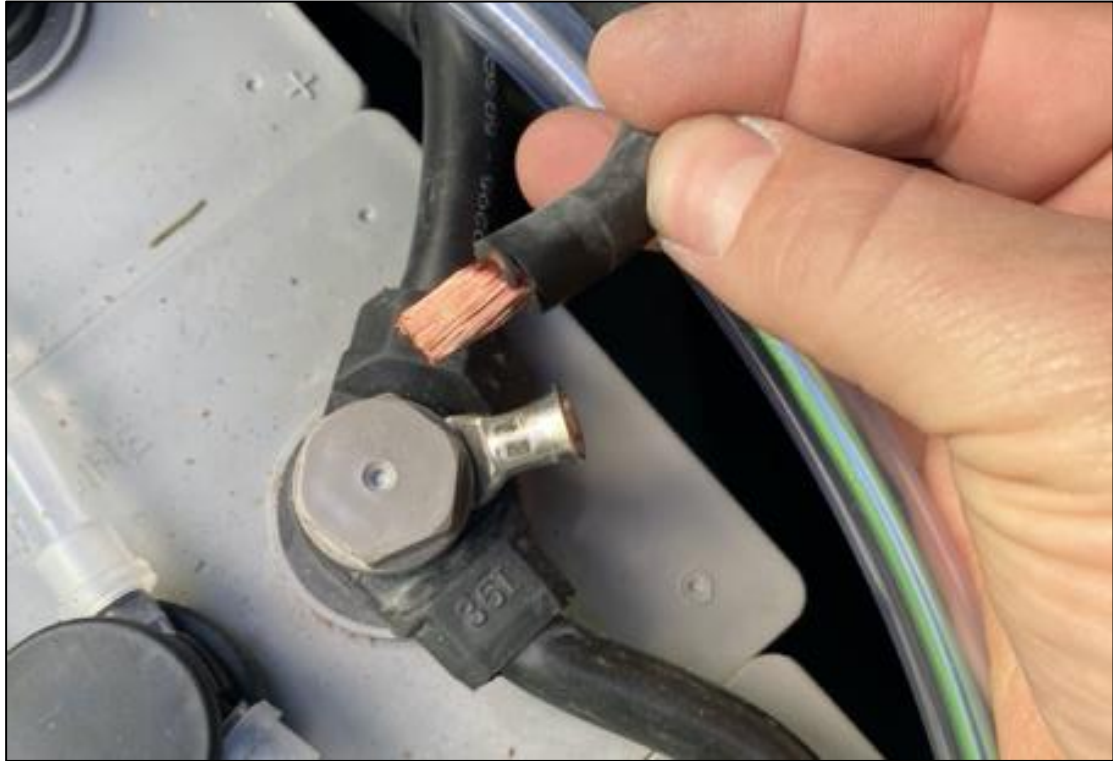
When examining the inverters negative crimped connection to the battery pack with the isolation tape removed, the wire pulled out of the crimp connection with little force.

Photograph 8 – Cable end crimped using improper tooling. Pulled out of connection using very light force.

Battery termination is poor. Improper tooling used to make connections. Cables pull out of terminals with light force.	All terminations should be correctly crimped using the correct tools. Copper tube terminals should be covered with heat shrink.

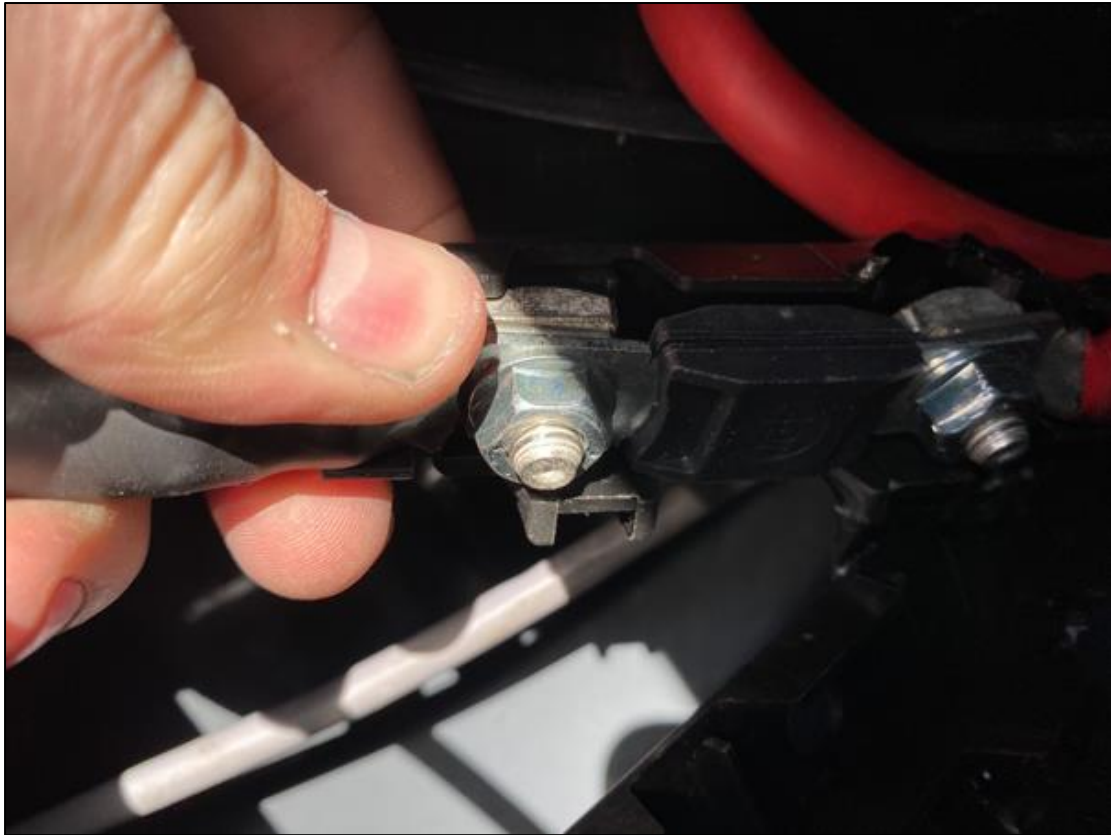
At the time of inspection, the positive DC supply of the inverter was found with a single 400-amp fuse supplying both inverters. The inverters should be individually fused at a rating of 200-amps (according to the manufacturer's installation guide).

Photograph 9 – Incorrectly sized inverter fuse not sitting in housing correctly. Originally wrapped in insulation tape.

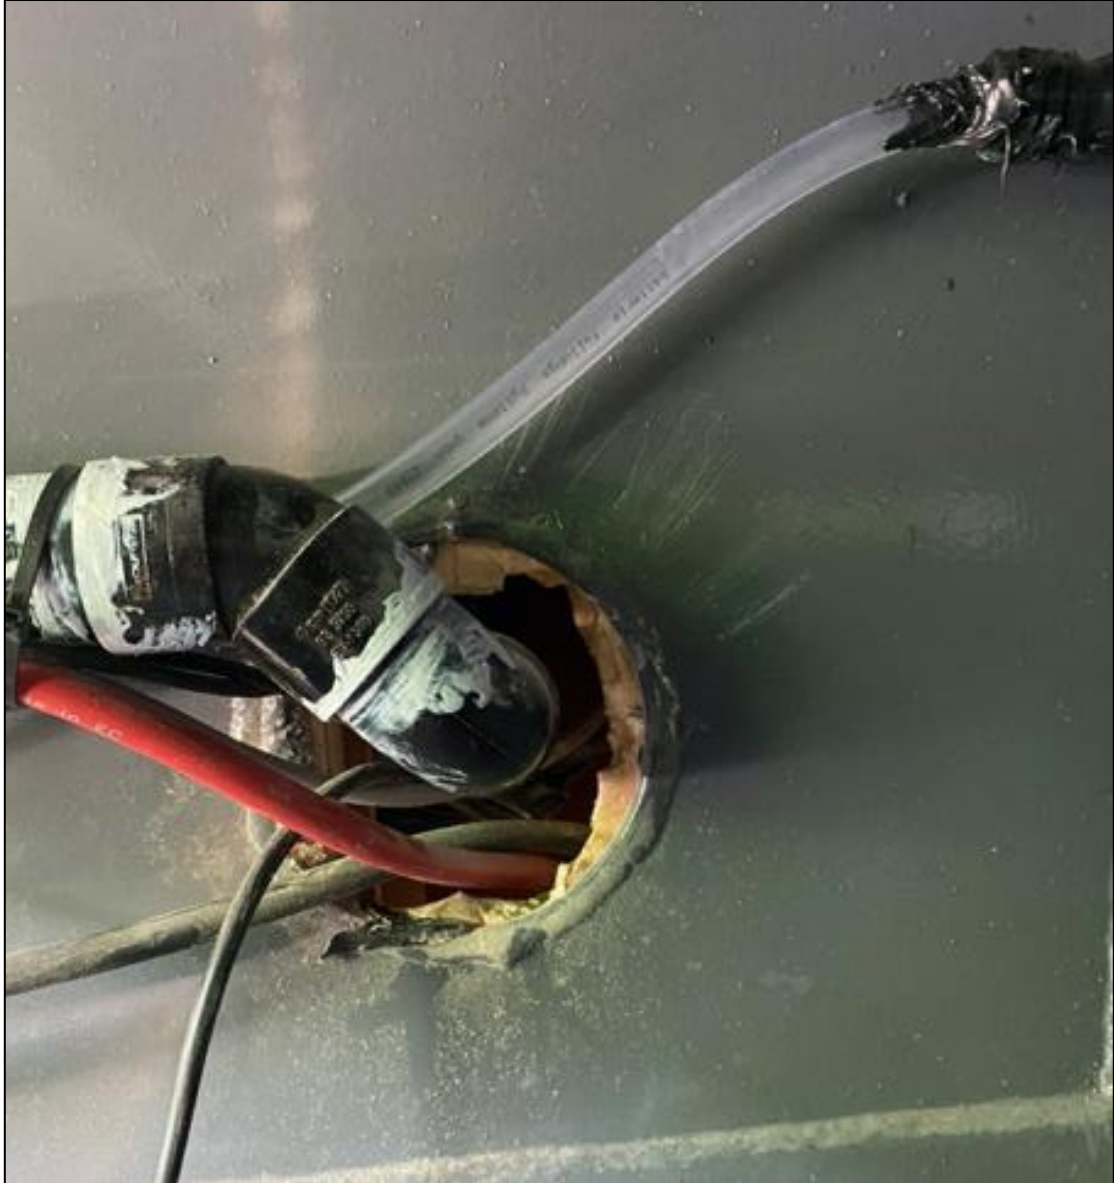
At the time of inspection, cabling to the inverters was found running through the opening in the metal bulkhead without any sheathing protection.

Photograph 10 – Cabling running through bulkhead without chafe protection.

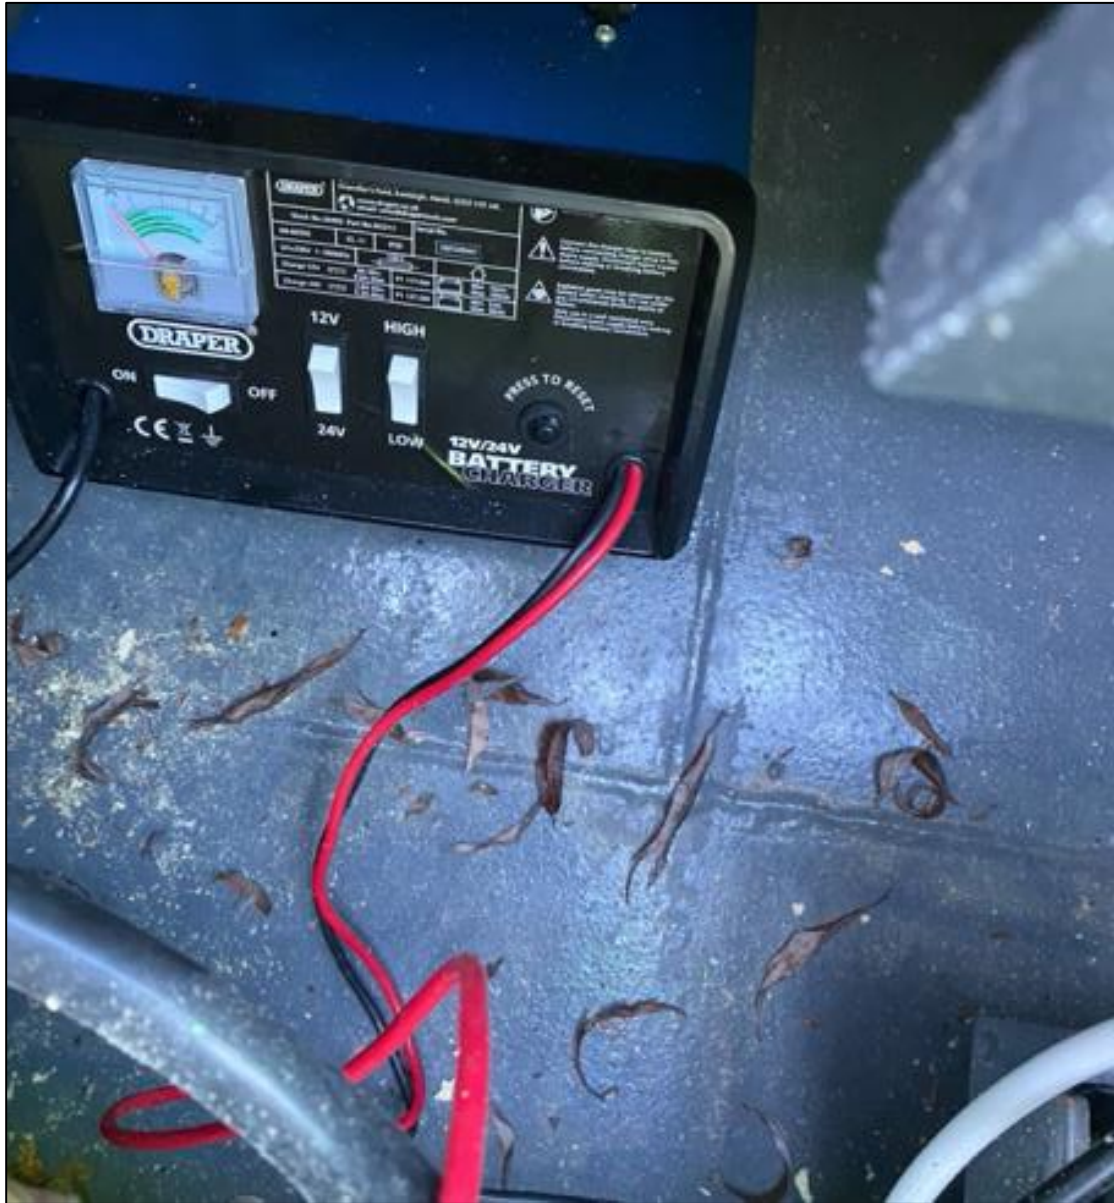
The draper charger has been permanently wired to the vessel without any DC protection. The Draper BDC11 charger is designs for use in a home workshop environment. It is not designed to be permanently installed and does not have any kind of autosensing for shutting down once the batteries are fully charged. Furthermore, the battery charger has not been secured.

Marine grade chargers are generally IP rated to a grade suitable for the marine environment. The importance of using a suitable marine charger onboard vessels cannot be overemphasized. Marine chargers use isolated type transformers with primary and secondary coils that are only connected magnetically. No electrical connection is present between AC and DC circuits. Less expensive automotive type chargers use an autotransformer, whose windings are not electrically dependent of each other. If the two circuits are not isolated there is a danger of stray currents being introduced into the vessel that pose a shock hazard, and may setup stray currents in the water around the vessel (Brotherton, M. and Sherman, E., 2003. *The 12-volt bible for boats*. 2nd ed. Camden, Me.: International Marine/McGraw-Hill).

Photograph 11 – Automotive, non-automatic charger connected to bow thruster batteries.

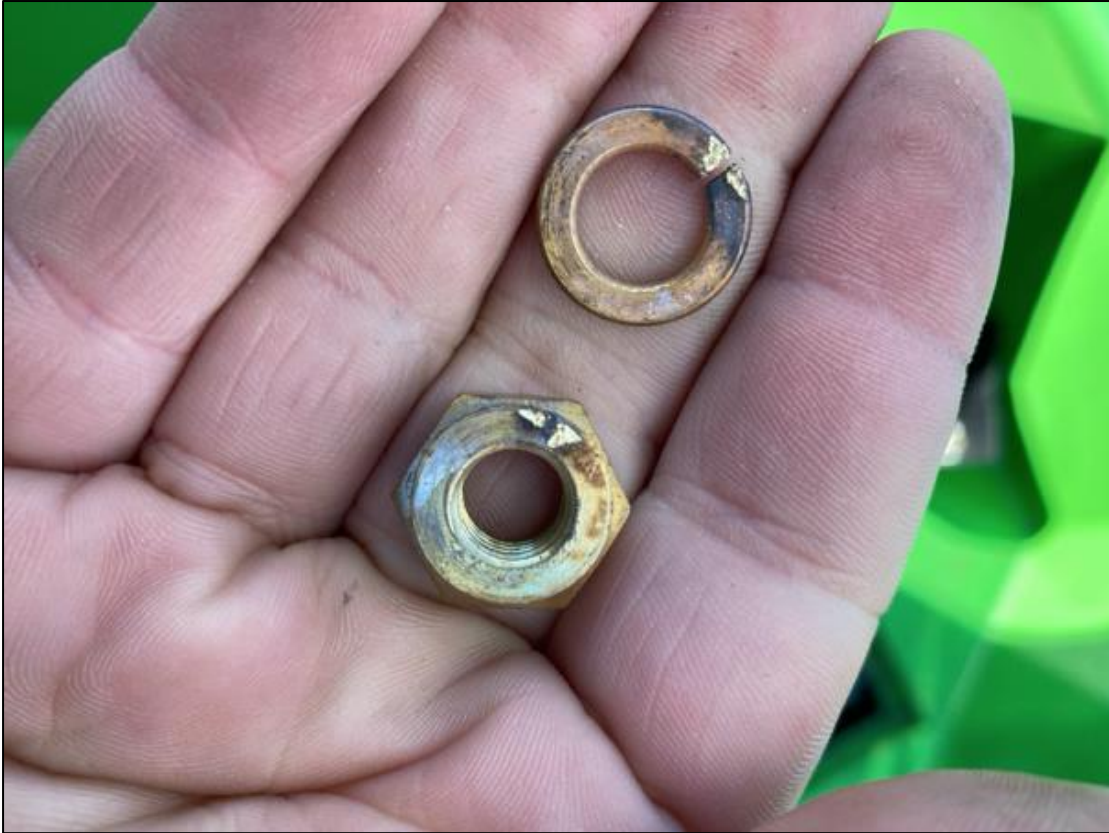
At the time of inspection, the main negative terminal connecting the thruster to the battery pack was found loose. Evidence of arcing by way of burn marks were present on the thruster's negative power post, connecting nut and washer.

Photograph 12 – Nut and washer found loose on negative bow thruster terminal showing signs of arcing/excessive heat.

Termination/connections on the bow thruster were found loose. Evidence of arcing and excessive heat were present.	Ensure all electrical connections are well made and fastenings are tightened to the product manufactures specification.

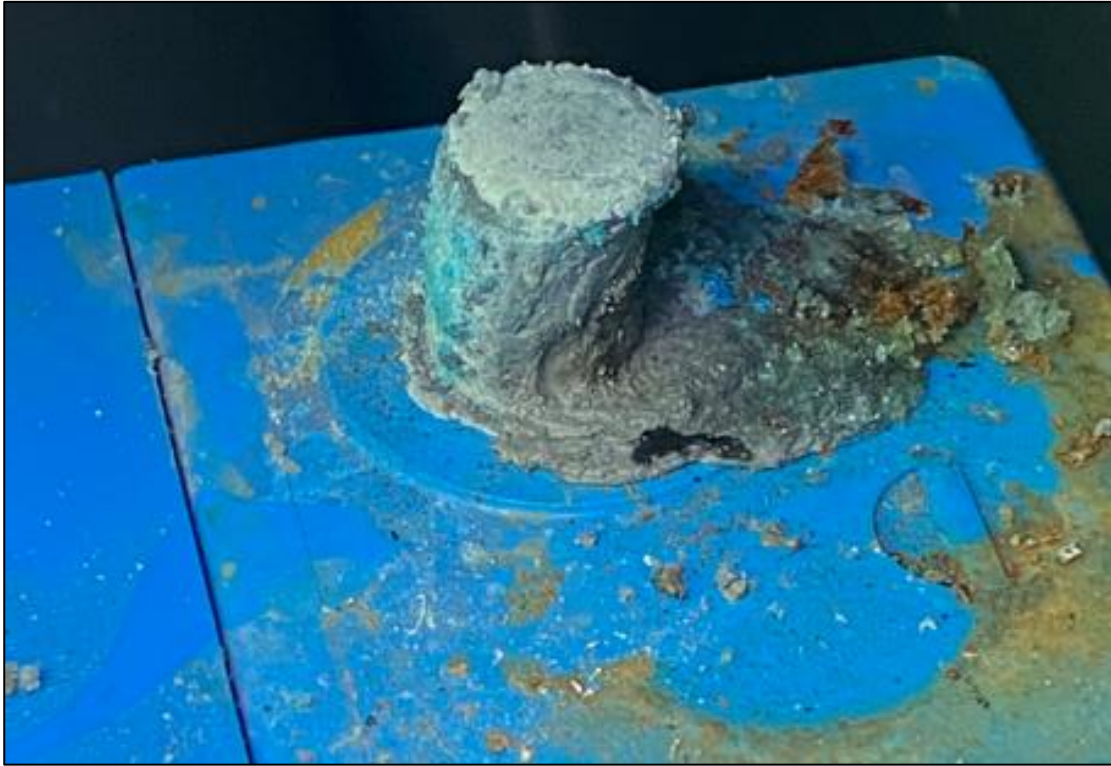
At the time of inspection, the battery link wire (series connection) terminal on the aft most battery was found loose. Evidence of heavy arcing between the battery terminal post and battery terminal was present. The battery post terminal has been partly melted. A new battery is now required.

Photograph 13 – Bow thruster battery post (negative) showing severe signs of continuous arcing due to poor connection/loose terminal.

Loose termination on bow thruster battery to battery series linking wire. Battery terminal post has melted.	Replace battery pack. Correctly install new terminals. Ensure terminals are tightened to the manufacture's specification.

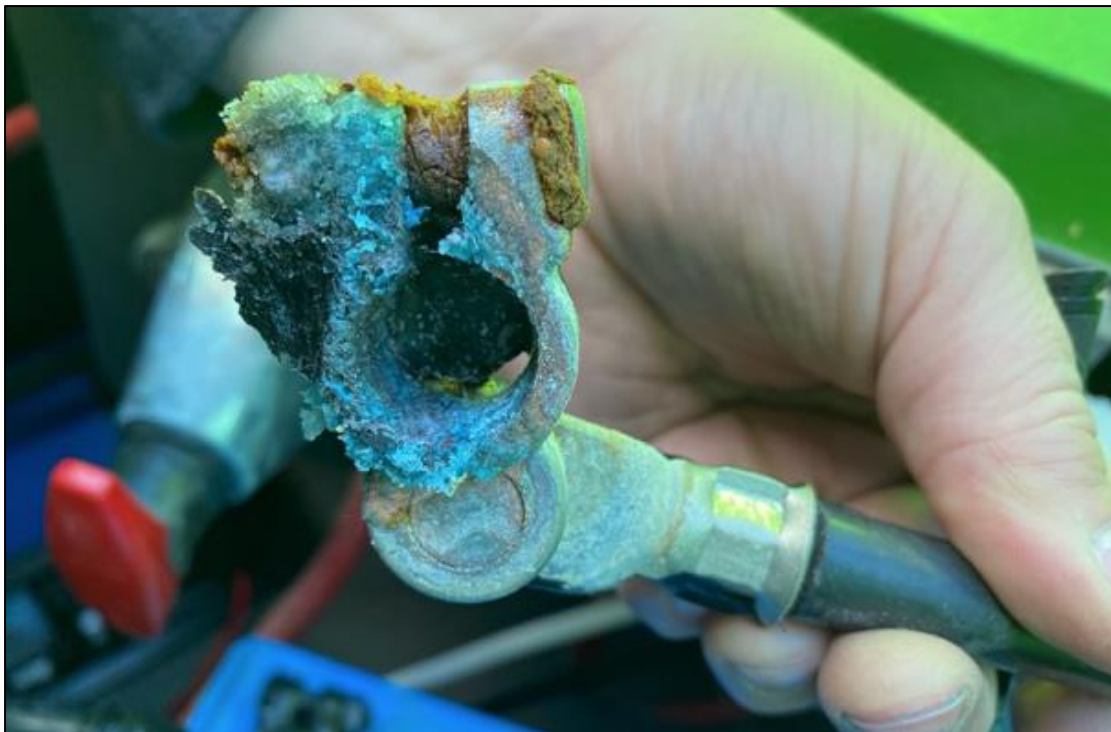
Photograph 14 – Bow thruster battery clamp (negative) showing severe signs of continuous arcing due to poor connection/loose terminal.

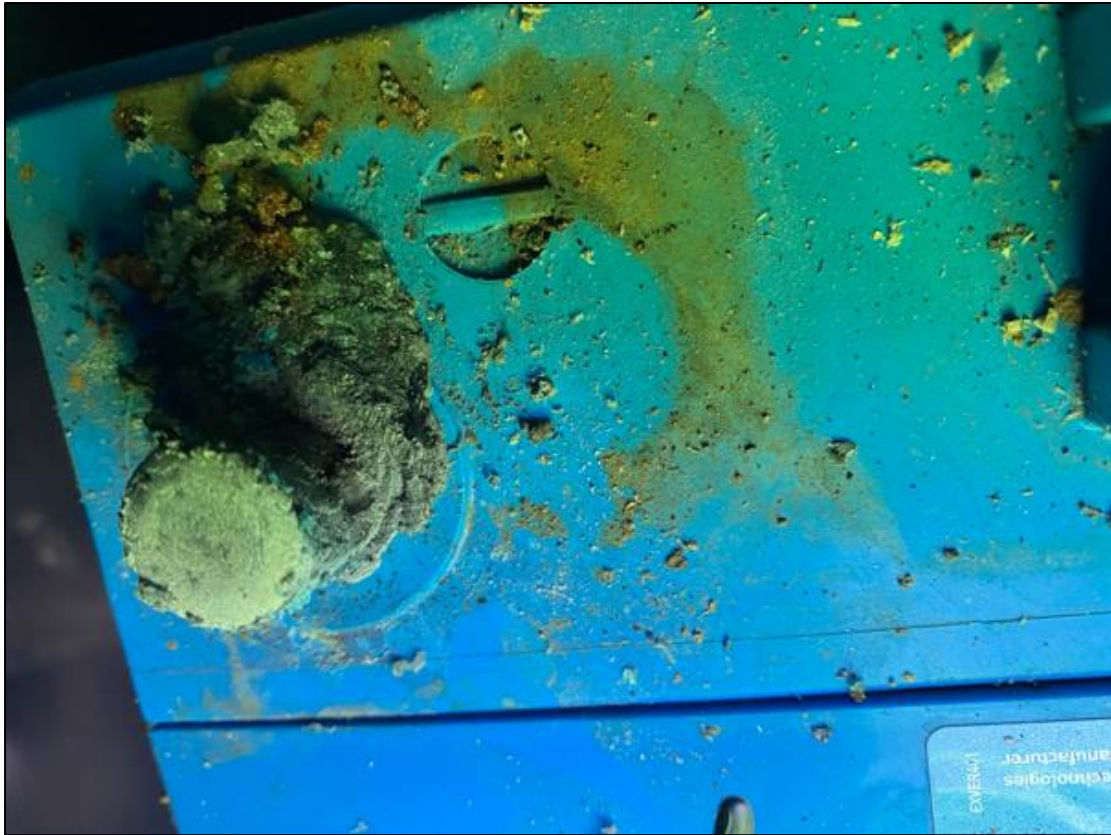
Photograph 15 – Bow thruster battery post (negative) showing severe signs of continuous arcing due to poor connection/loose terminal.

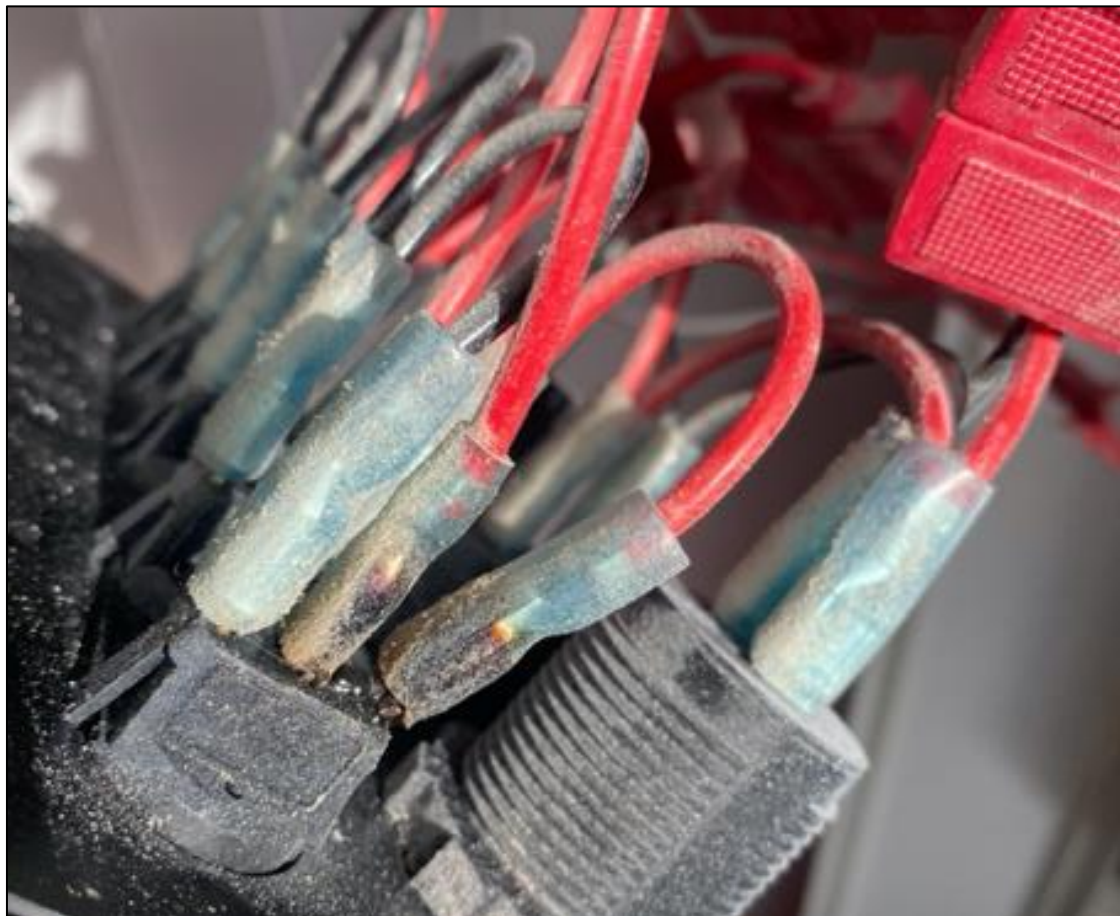
The switch marked 'forward power' appears to control the two water pumps. The forward power switch is showing evidence that suggests it has been hot to the point of melting the switch mechanism. The switch has now melted into the permanently on position.

Photograph 16 – Evidence of high resistance/excessive heat to water pump switch

(ceased closed)

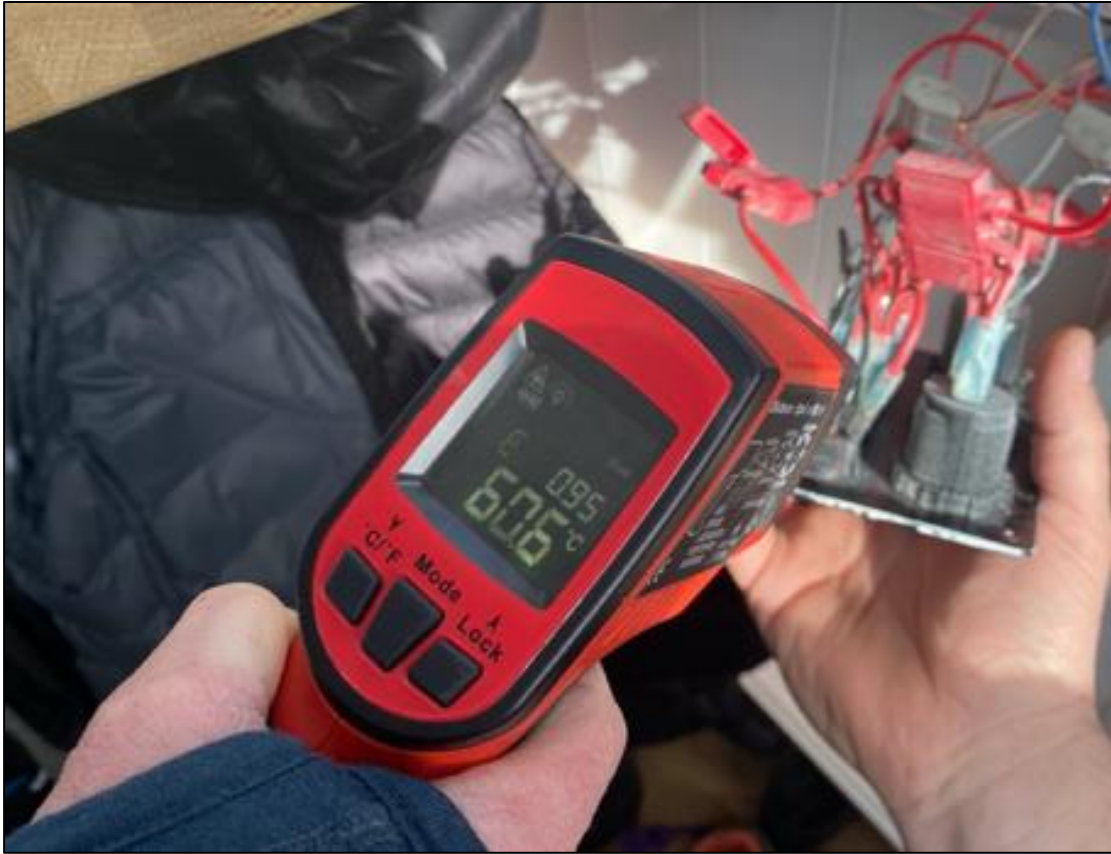
Photograph 17 – Switch showing a temperature of 60.6°C after 60 seconds of operation.

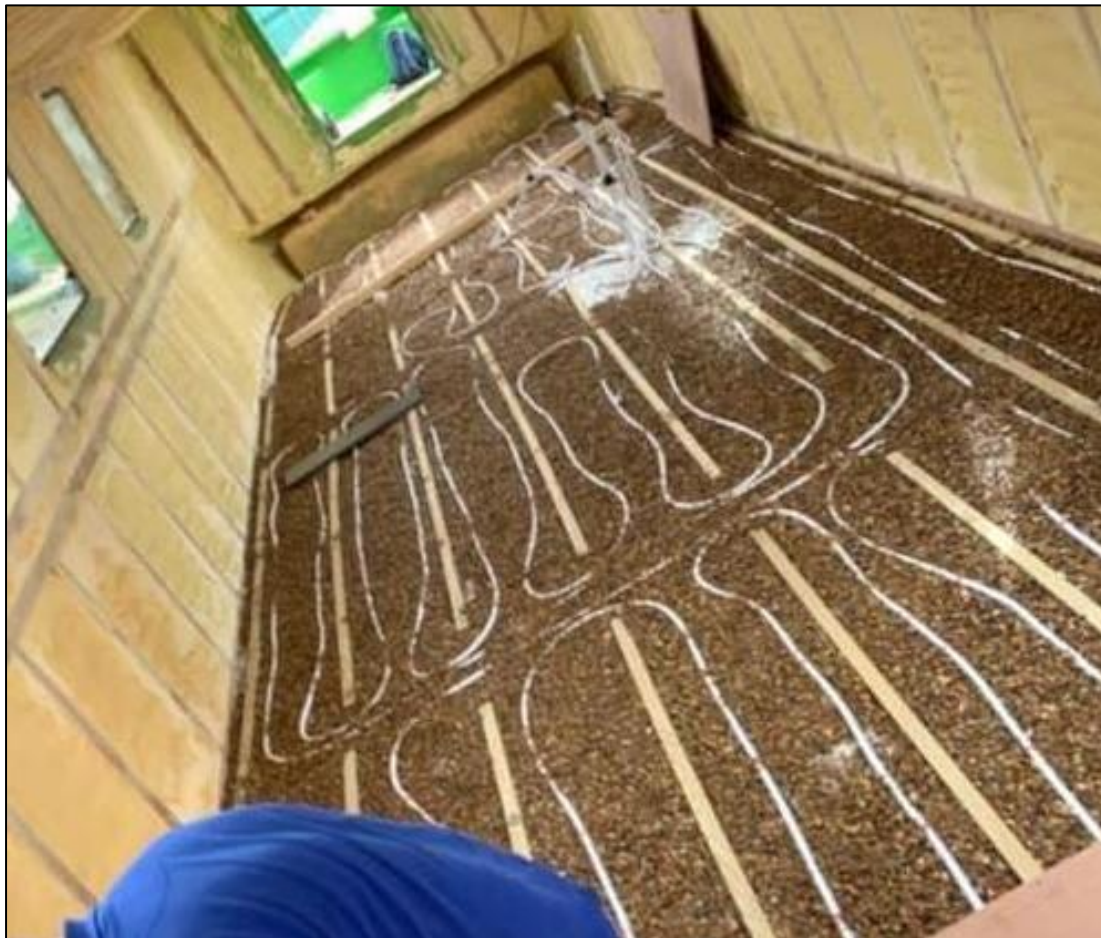
It is understood that the intension of the pea shingle is to create a thermal mass. A monolithic effect as would normally be created with cement/sand screed mixture under the ceramic tiles within a house.

The term monolithic is used to describe a single piece of rock/stone. In order to create thermal storage as seen in concrete structures, the pea shingle would need to be mixed with a binding agent to create a single mass. The individual stone will simply not work as required. Additionally, the type of stone used may contain high levels of Silica and will act as an insulator.

Photograph 17 – Underfloor heating arrangement. Photograph taken during build, taken by owner.

13.4. Heating and Plumbing		
■	The underfloor heating system is not effective. At the time of inspection there was no temperature difference measured over a 6-hour period.	Multiple issues with underfloor heating system. Independent inspection from specialist recommends removal and reinstallation.
■	Multiple plastic pipe fittings/connections are not made correctly. Cross threading of fittings. Poor workmanship.	Make all connections as per the product manufacturer's recommendations. Fittings are not designed to take the weight of a run of pipework.
■	Excessive force applied to multiple fittings due to poor workmanship. Incorrectly/unsupported pipework.	Make all connections as per the product manufacturer's recommendations. Fittings are not designed to take the weight of a run of pipework.
■	Plastic fittings found within 1 meter of uncontrolled heat source (stove).	It is recommended that all pipework within 1 meter of an uncontrolled heat source is metallic.

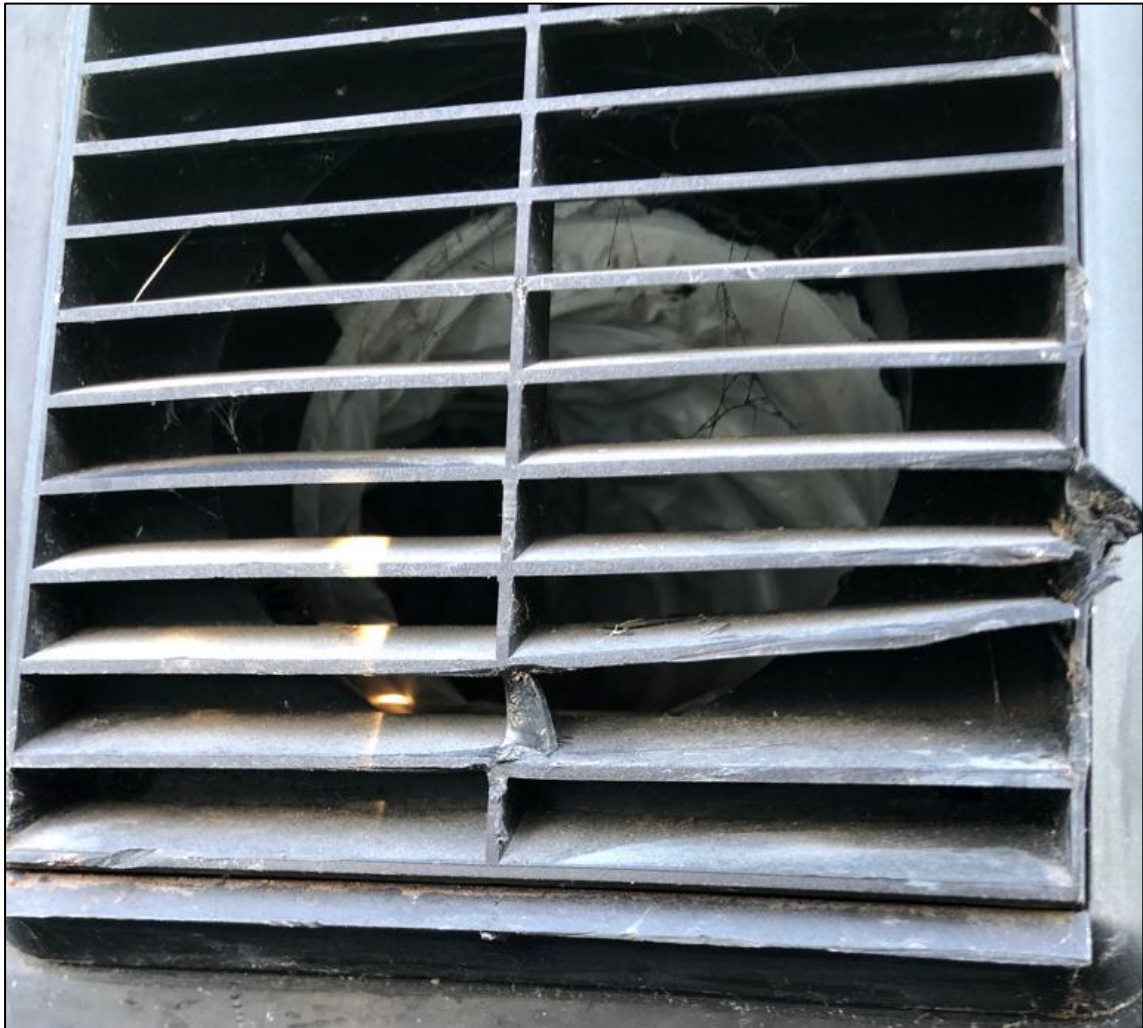
The aperture for the toilet vent in the vessels hull is approximately 150mm from the vessel's waterline. The plastic fitting is not sealed to the vent pipework. Any wave higher than 150mm will mean river water is entering the vessel without any means to drain. According to the vessels 'Declaration of Conformity' the vessels is intended design category is 'D'. D category vessels should be considered and designed for a wind force up to, and including four, and significant wave height up to, and including, 300mm, with occasional waves of 500mm maximum height.

Photograph 18 – Toilet vent/open to hull.

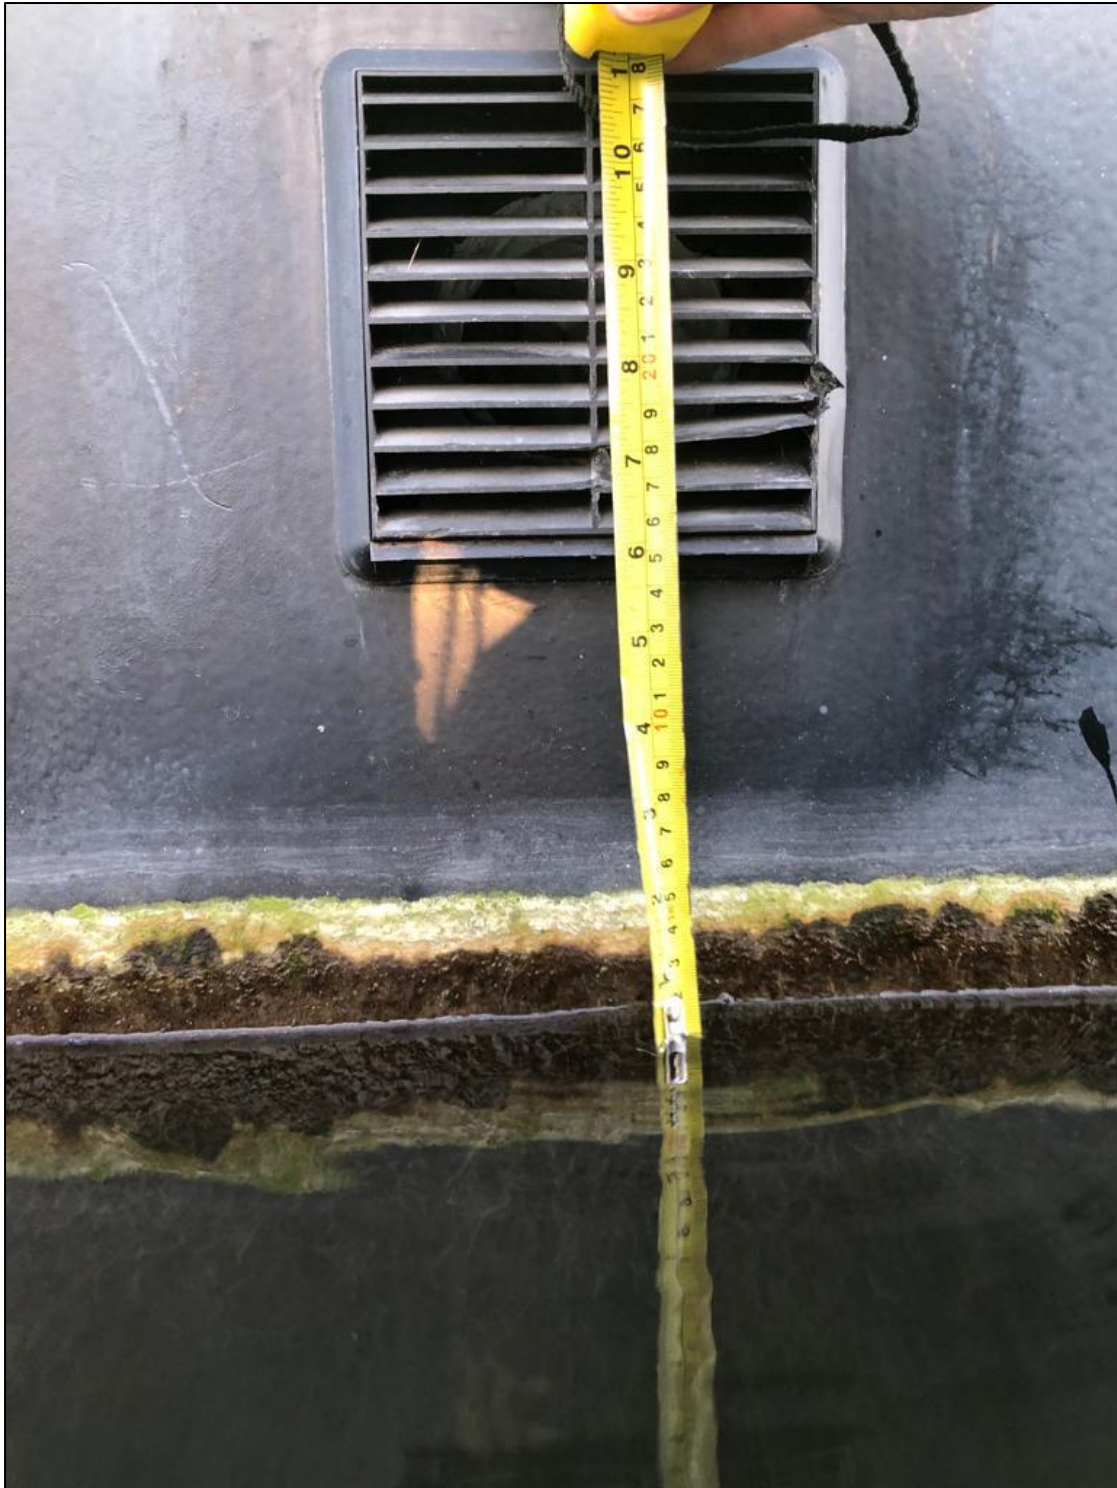
Photograph 19 – Aperture in hull cut at 150mm above waterline.

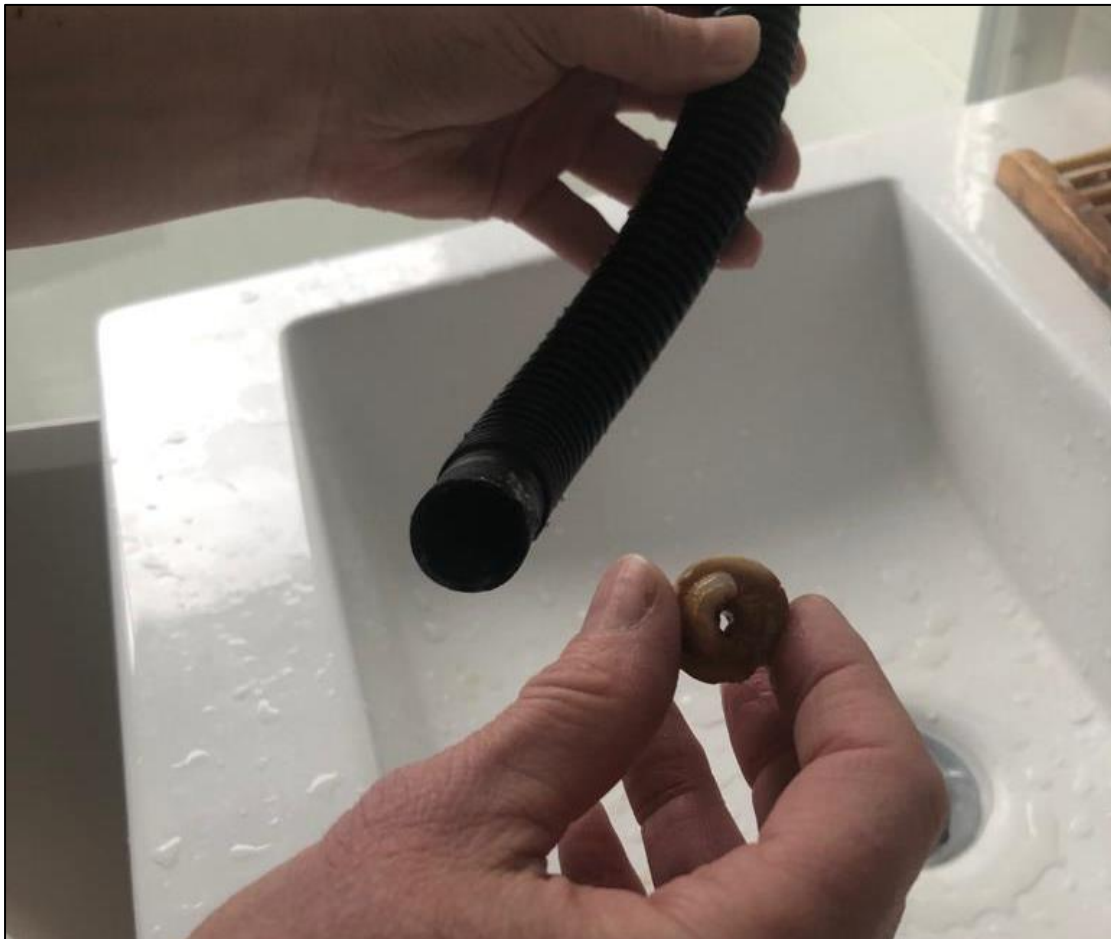
Reportedly, pre-inspection, the owners of the vessel experienced issues with the liquid section of the toilet system backing up. Upon further inspection, silicone sealant was found partly blocking the liquid pipe between the toilet and the sump pump drainage system.

Photograph 20 – Silicone sealant found by owner blocking urine pipe.
